## How a 'Dose of the Profiler Challenged Assumptions

Gamma Graphics Services (GGG)

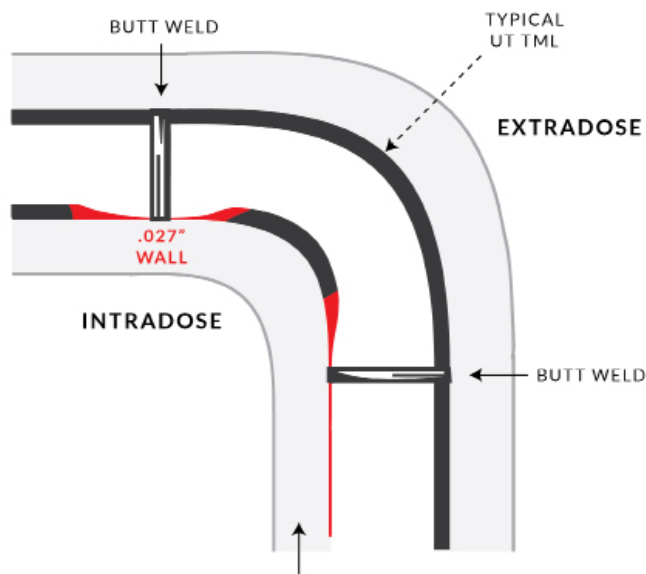
"What are you doing?" he asked. "It never erodes there." Sure enough, a large area on the intrados of the pipe that was supposed to be .325" had eroded down to .027"—paper thin.

It was time to prove that the Profiler's results were accurate. I told him he could kick me out of his plant if I was wrong, so he brought out his welder and cut out the elbow. Sure enough, that pipe was incredibly thin at the intrados, yet had only mild erosion at the extrados.

There is a deflection plate in the feedwater heater that causes the water to enter the elbow in a straight line, but the plate had broken off. So instead, the flow was entering at an angle and swirling within the pipe, creating a different erosion pattern. Over the years, we have found that this is a surprisingly common issue.
