Age Before Beauty, but Data Before Age

Gamma Graphics Services (GGS)

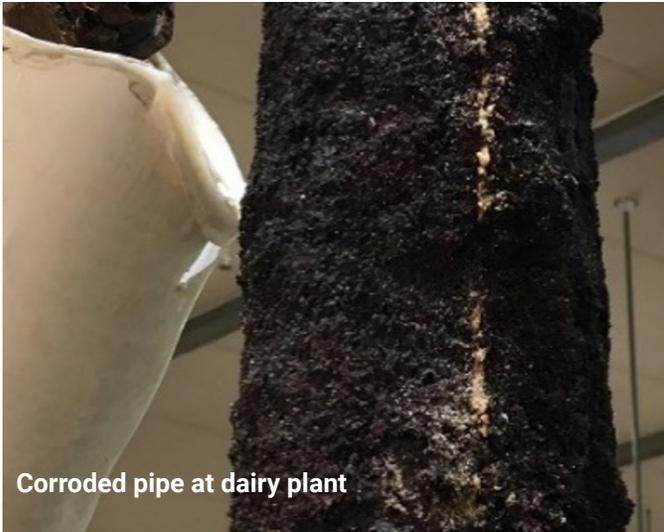
I had been called in to repair a piece of equipment that was tied into their ammonia pipe system. When we pulled off the insulation to get access to a coupling that would serve as our end point, we discovered some rust that we traced to one of the worst looking pipes I had ever seen. Pitted and brown, it clearly needed to be replaced—in fact, it looked as though it should have been addressed some time ago.

I called Jim at GGS to see if he could provide some insight. He pulled a copy of the report and read to me the notes that had been made about this specific section. "We noted 7% wall loss, along with evidence of pitting and corrosion," he said.

“See, Jim?” I pressed, “Not only is it brown and covered in corrosion, but as you can see in the second photo, after we cleaned the pipe, the pitting is so significant you can see it from a few feet away! You must admit, this needs to be replaced with new pipe.

Jim acknowledged, “No question, these pipes are ugly. But the presence of corrosion doesn’t necessarily equate to wall loss significant enough to replace these pipes. You have to look at the data—and the data says that pipe is ok.”

change in the manufacturing process of pipe over the last 20 years, the existing, pitted old pipe is actually more effective than the new pipe that we planned to install in its place.

“Even with the pitting, the remaining wall thickness on that pipe is more than you would have on a new section of pipe. If you simply coat that pipe in a protective gel and fix the breach in the vapor barrier, which you need to do anyway, you should see no new corrosion on that section of pipe. “

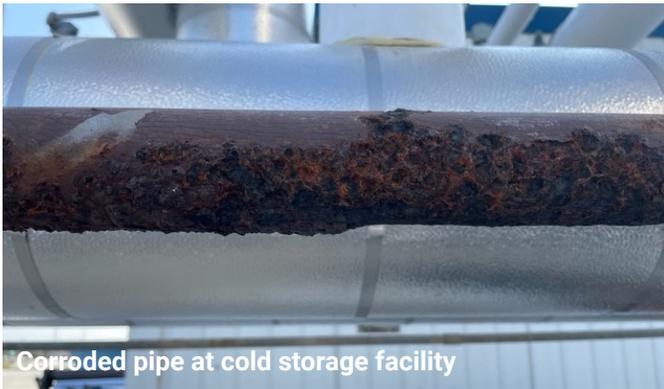
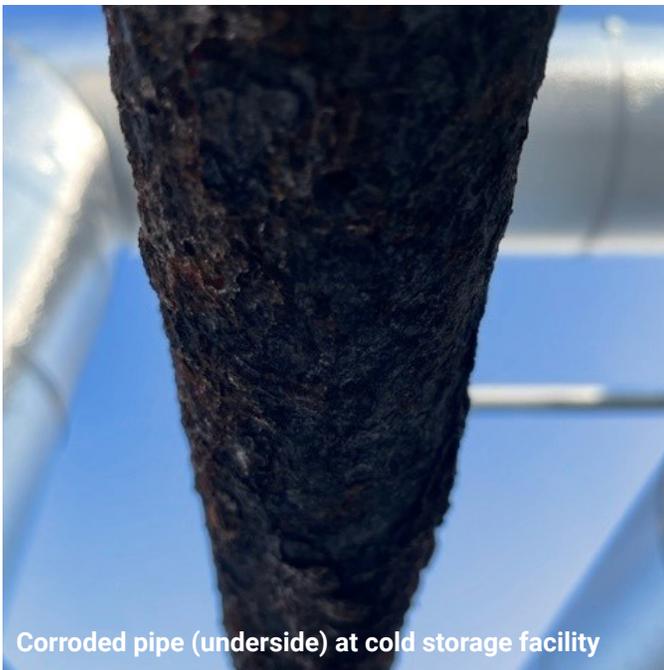
The center of the pipe looked terrible. The entire bottom half of the pipe was corroded. Why wasn't this replaced after we had the system tested? Either we overlooked this a few years ago, or the NDT report was wrong.

The report gave me wall thickness values at 2 locations on this pipe, both showed corrosion with minimal wall loss, less than 3%.

He reviewed the measurements noted in the NDT report and assured me they were correct. "I know it looks bad, but I wouldn't replace this pipe."

Jim laughed. "You're the boss, but before you make that decision, do you have caliper handy?" I did. "We verified the line size when testing so we know this pipe is 1.5-inch schedule 80. The outer diameter (OD) for this size from the mill should be 1.900 inches. Since only the outside wall of the pipe is susceptible to wall loss, could you measure the OD of the pipe and let me know what you get?"

First, I measured the worst area where corrosion had crept up to the top of the pipe – the caliper read 1.891 inches. Jim did some math and gave me the verdict, "at .008 less than nominal, the wall loss on this area is 4%." The measurement, while only an approximate number, was in line with the NDT results.

Surprised, but relieved, I thanked Jim for easing my concerns and entered the work order. The pipe would be cleaned and coated with pipe gel before re-insulating.
