DEMYSTIFY CUI

Predict and Pinpoint Threats to Your Piping

This paper presents actionable data to help system managers develop an approach for monitoring and managing the integrity of their piping that respects available time and funds, and meets requirements set by the United States Environmental Protection Agency (US EPA) and Occupational Safety and Health Administration (OSHA).

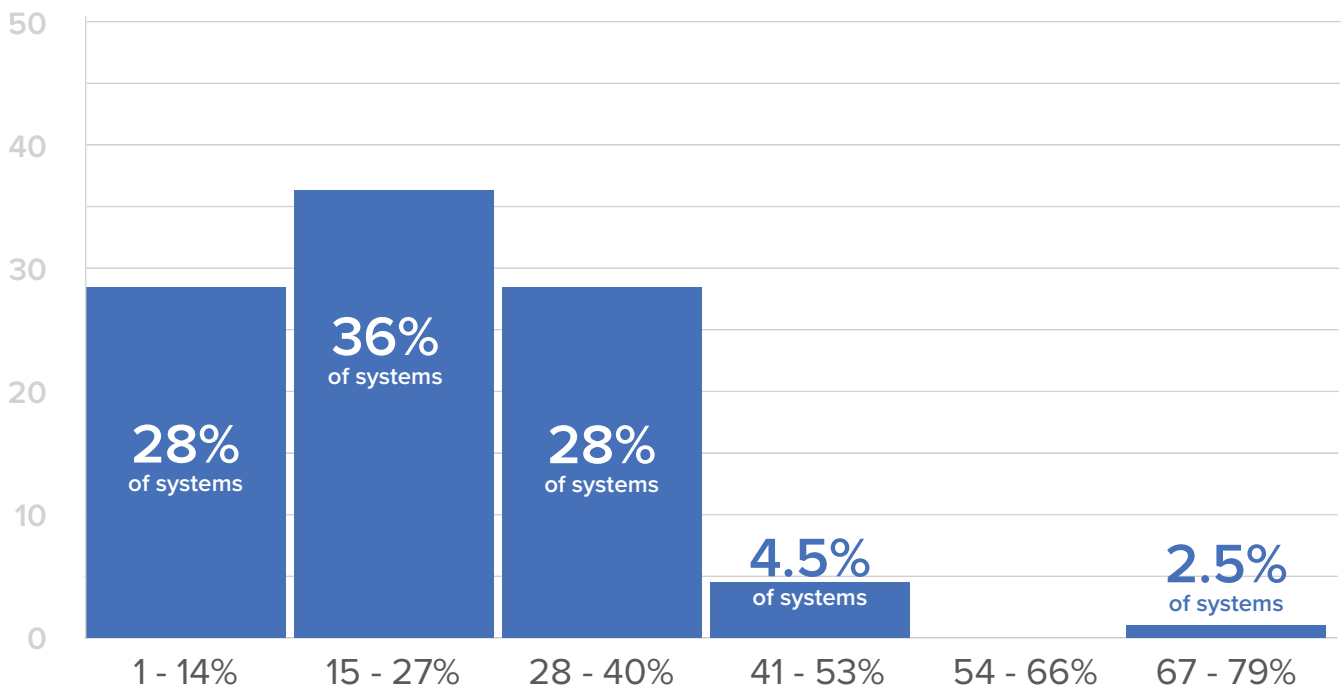
PIPING WITH WET INSULATION

Today, an average of 23% of an aging ammonia refrigeration system has rogue moisture in piping insulation, and zero systems reveal *all* trapped moisture visually. Protective measures to combat rogue moisture in insulation show promise as these figures continue to decline (down from 30% in 2015).

The lowest recorded amount of water trapped in insulation was 1% of the system; the highest was 73%.

Based on study of systems evaluated in the U.S. from June 2021 to May 2022

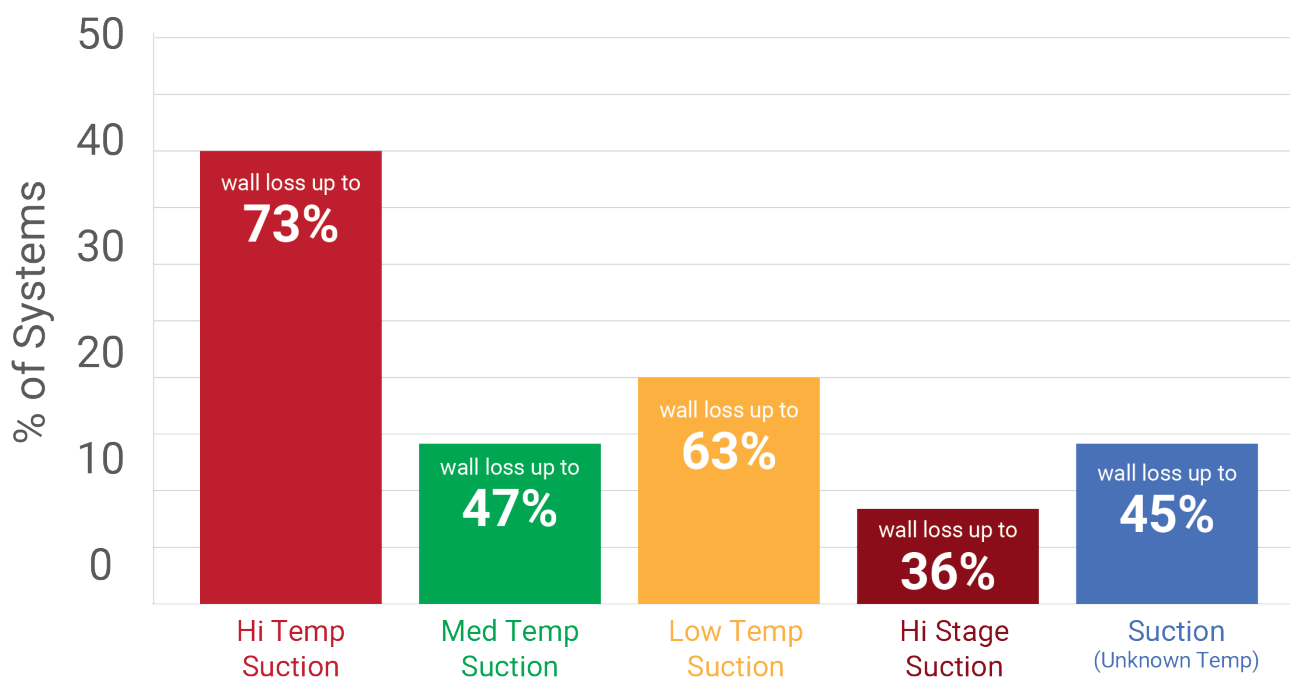
WALL LOSS ON SUCTION LINES

For example, pipe wall loss was as high as 63% on low temperature suction lines, and 68% of systems exhibited pipe wall loss in excess of 25% up to 73% on suction lines.

Overall, 28% of systems were reported to have areas with pipe wall loss in excess of 50%.

The highest recorded loss, not including leaks that occurred as a result of complete metal integrity failure as a result of corrosion, topped out at 80% wall loss (or 20% remaining wall thickness).

Based on study of systems evaluated in the U.S. from June 2021 to May 2022

*Loss less than 25% not included in results

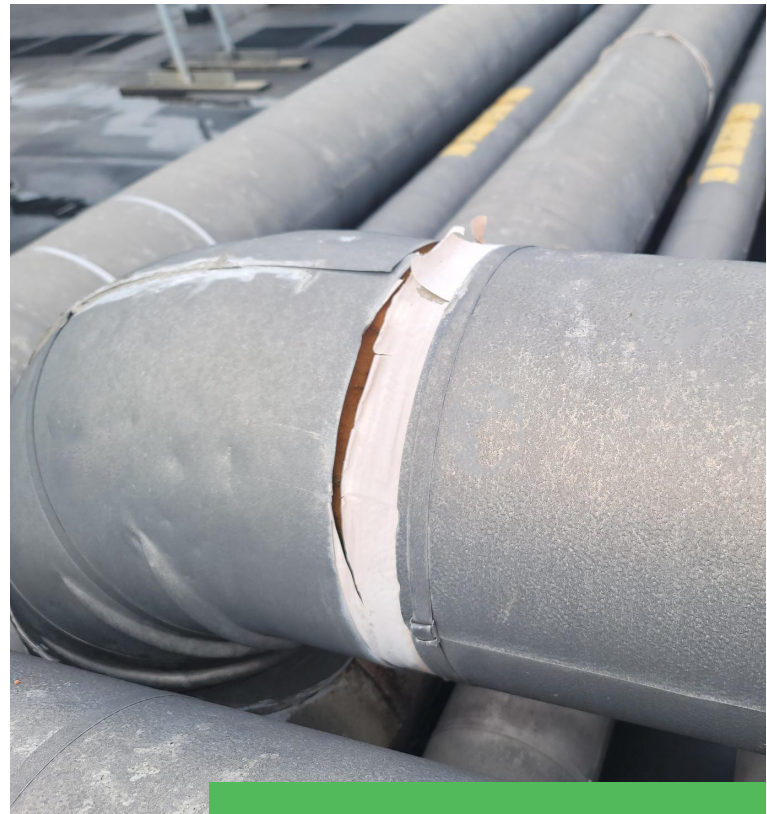
Insulation conditions such as damaged or missing components of the vapor retarder can vary. Any damage can allow moisture through the vapor retarder, and once it is past the vapor retarder it is there to stay - look for:

1. Jacketing separations
2. Holes in insulation
3. Hail damage
4. Split seams
5. Crushing from physical damage
6. Weld strikes or other electrical damage that penetrate jacketing

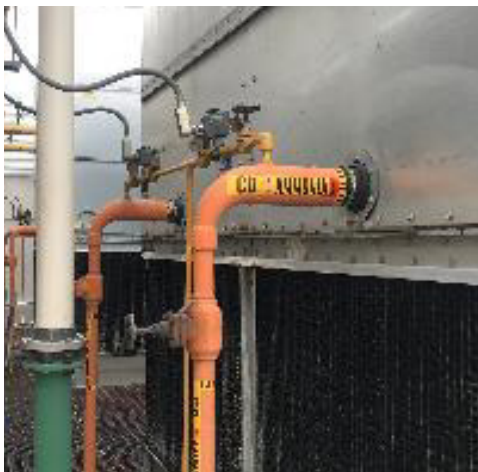
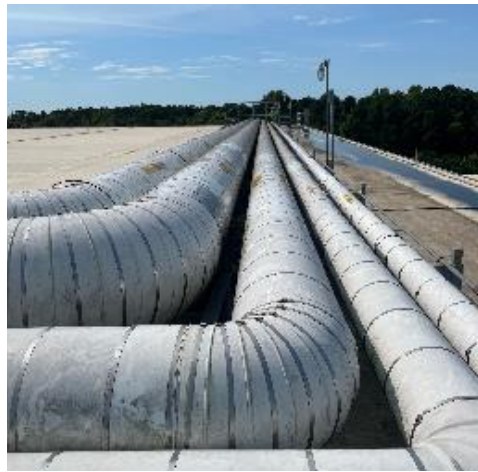
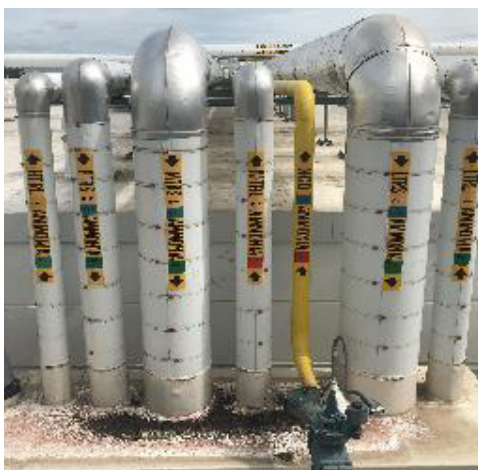
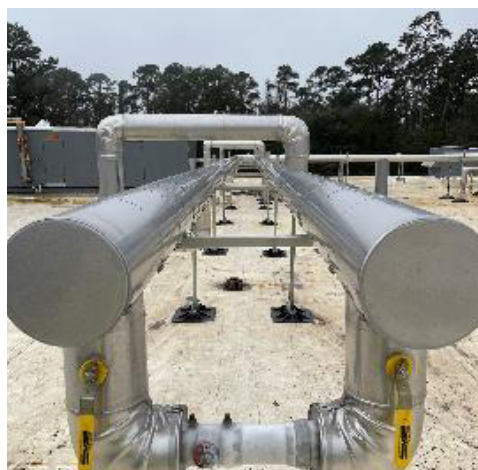
In addition to damage being a reliable catalyst for CUI, the areas where piping is most vulnerable are:

1. The intersection of a pipe segment and major pieces of equipment
2. Before and after pipe direction changes (i.e. elbows, tees, reducers, etc.)
3. Wall and roof penetrations
4. Insulation terminations (i.e. valve groups, end caps. etc.)

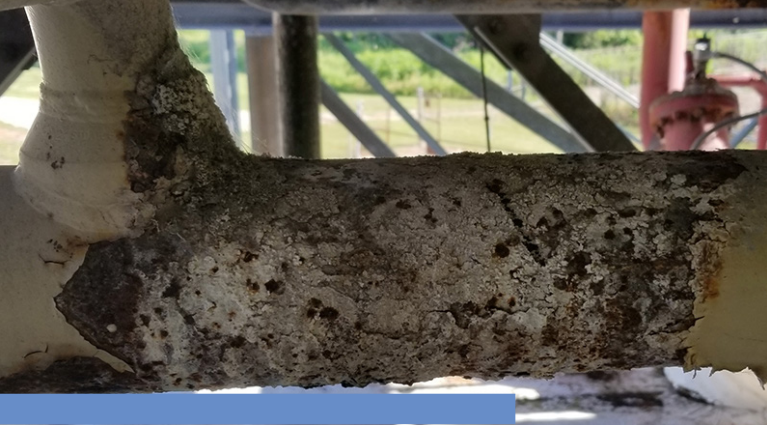
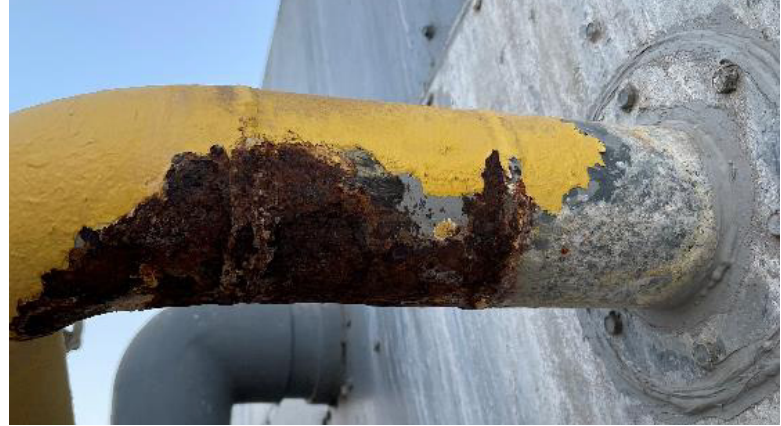
1. Piping near condensers or a cooling tower area.

This equipment can produce chemical and mineral rich mists that are especially damaging to pipe jacketing and bare piping. This mist can leave a mineral type of deposit on surfaces and is prone to corrosion on metal unless cleaned and coated regularly. This is especially detrimental for piping that is not properly protected, like in areas where piping penetrates the walkways, or when the design does not allow for enough room to properly inspect or maintain coatings.

3. Any area where piping penetrates a boundary such as a roof or wall is difficult to inspect or maintain.

Additionally, the piping is oftentimes uninsulated, leaving the bare piping directly exposed to potential moisture. In many systems these areas are unprotected as they pass through the boundary. Integrity depends entirely on a secure adhesive or sealant, such as caulk, to provide weatherproofing.

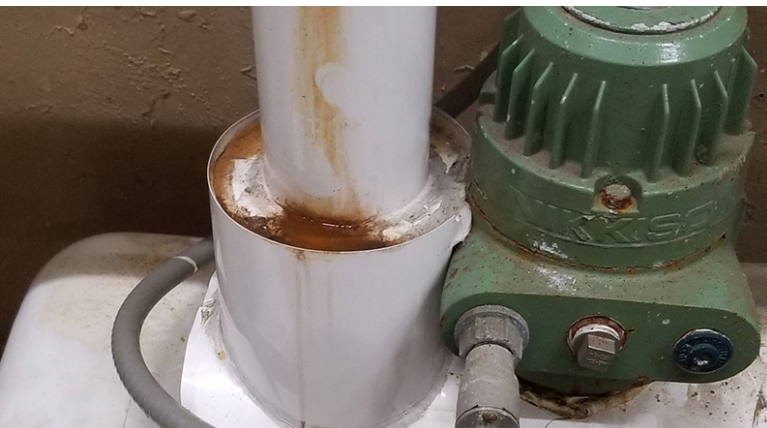
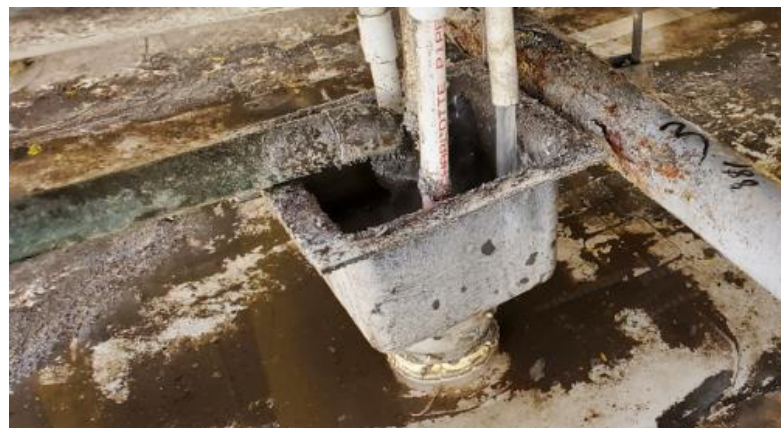
2. Gravitational pull is a hotspot for consideration, specifically related to pump outs and roof penetrations.

Pump outs are commonly installed in the bottom of piping for proper function. However, this positions the piping precisely in the area that collects water after compromise. Gravity pulls water to the lowest area - beneath the piping or low areas of the roof.

4. Congested roof drains.

Drains that are not regularly cleared can trap moisture and promote the growth of trees and other organics.

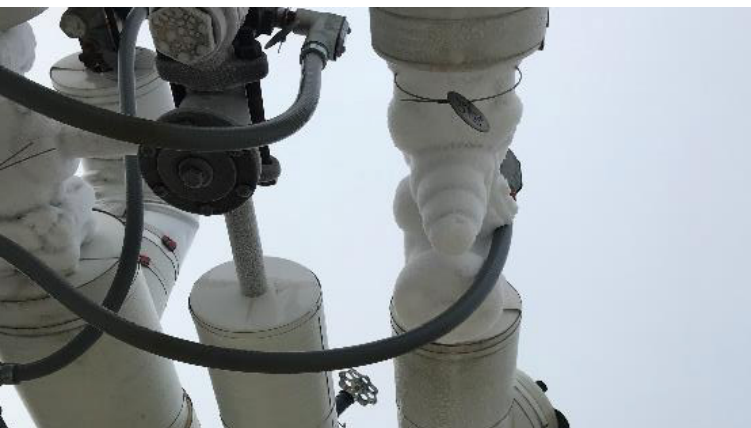
1. **Weak or missing gutters** that are not properly channeling rain runoff away from the piping.
2. **Poor or unmaintained caulking** at insulation caps.
3. **Screws in jacketing**.
4. **Design configurations that collect or hold water** such as insulated hand valves or other vertical oriented features. Although it may look good aesthetically, it could be destructive.
5. Be aware how **jacketing seam overlaps** could allow water to collect. Seams placed on top of the piping, while quite common, it invites water into the system.

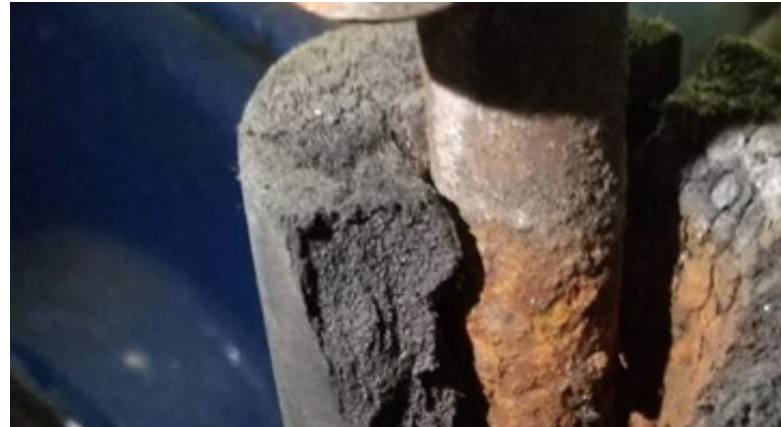
6. **Insulated to bare piping transitions at valve groups.** This puts stress on the unprotected bare piping as well as the sealing. If not well maintained, paint or coating will flake, and visible rust and corrosion will soon follow.
7. **Brackets covered by jacketing.** While it looks nice, it is another area where water will be invited into the system. Over time, the thermal cycling will cause enormous stress on the jacketing which does not expand but will separate at seams to accommodate.

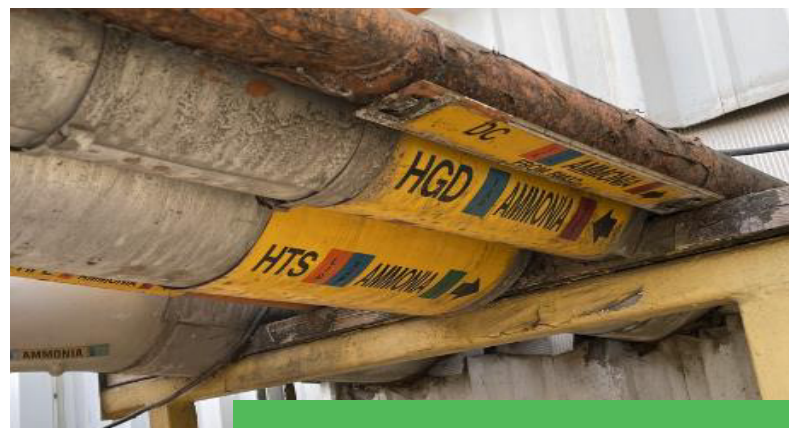
8. **Fiberglass and elastomeric foam insulation,** commonly used for residential air conditioning and plumbing, are prone to waterlogging and should not be used. Further, elastomeric foam insulation is commonly glued to the surface of the pipe with no outer protection from the elements – a warning sign that damage is imminent.

9. **Improper pipe supports** are hotspots for corrosion and mechanical wear on piping. Thermal piping expansion/contraction in ammonia refrigeration can create wear points on piping if not properly protected from the support itself. The threat is magnified if the bracket design does not allow for proper maintenance and coating of piping.

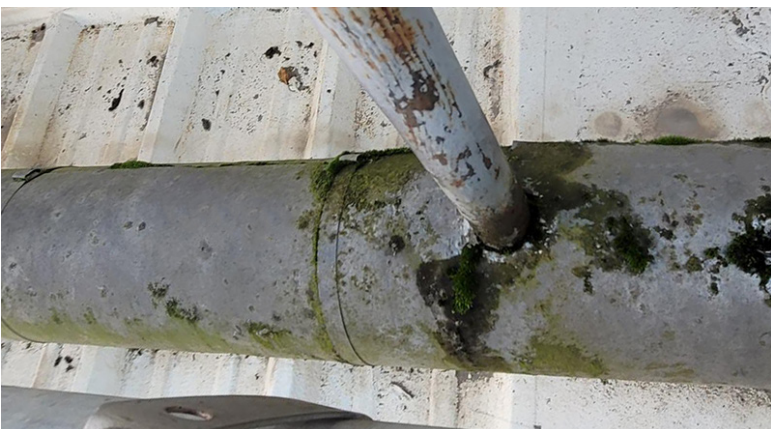
1. **Moisture dripping or ice forming around the pipe.** This is a sign that the insulation saturation has exceeded containment within the jacketing. Ice build-up on insulation typically occurs when water has compromised the vapor retarder resulting in ice being present from the surface of the pipe, all the way through the saturated insulation to outside the insulation jacketing.

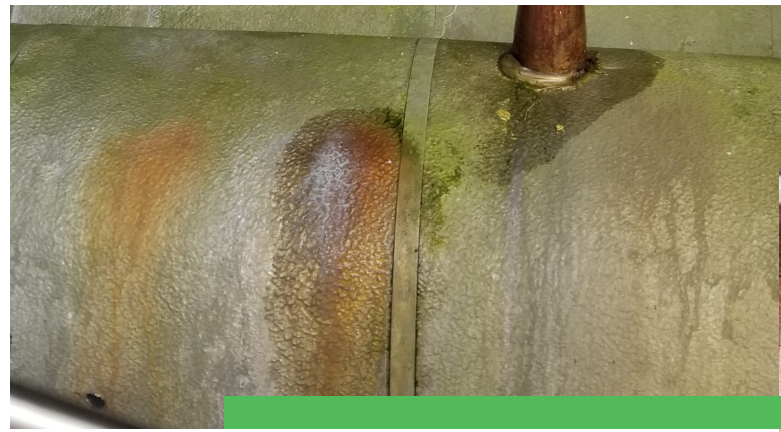
2. **Biological indicators** such as algae, moss or plants growing on the insulation.
3. **Rust stains on the floor of engine rooms.** Often times, this is found near valve groups where the defrosting process produces excessive water exposure.

4. **Rust stains on the insulation jacketing.** Rust staining or rust colored water from within the jacketing occurs as a result of degradation of piping or components contained inside the jacketing and insulation.
5. **Sagging areas** on a long run of pipe.
6. **Painted corrosion.** If the surface is not well cleaned of all rust before coating, paint will incubate the active corrosion and exacerbate the issue.

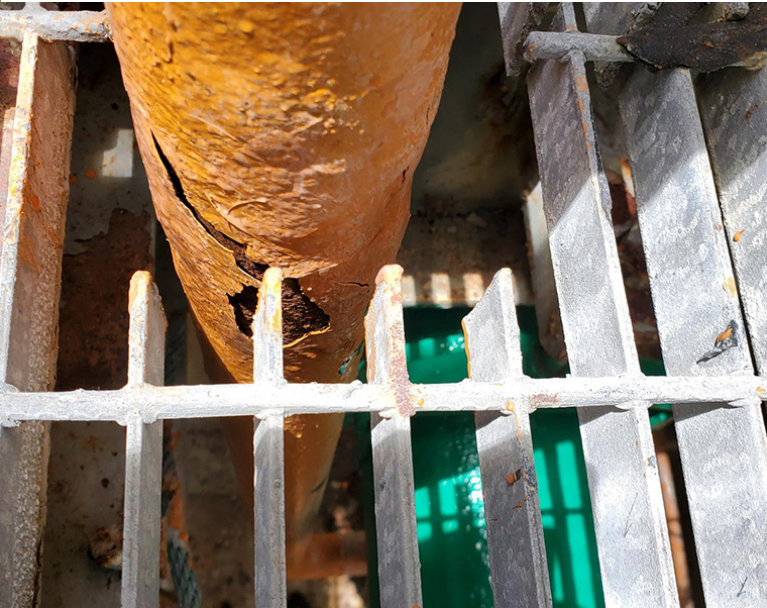
Where corrosion is present, remaining pipe wall must be measured to make an accurate assessment of priority. Corrosion on bare piping and CUI take on multiple forms and vary in how aggressive the corrosion advances.

Generally, blister rust is the most concerning. If your piping shows layers of peeling rust (or 'blistering') the corrosion is advanced, and the remaining wall thickness is likely not suitable for operation. The general rule of thumb for companies that exercise a conservative approach is to replace piping that exceeds 50% wall loss.

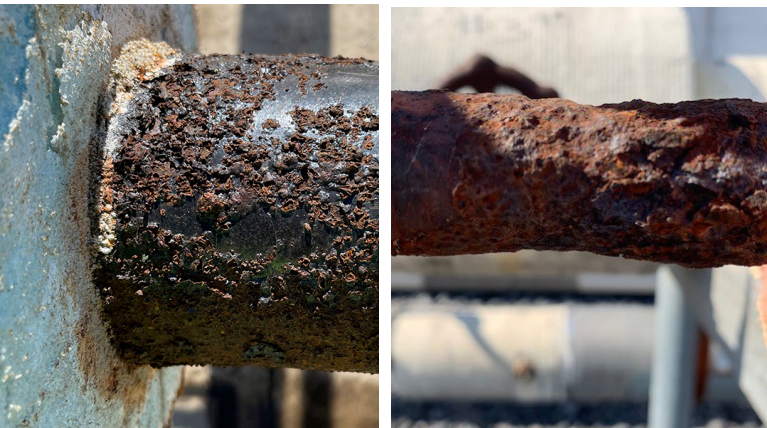
Pitting corrosion is the most common form of corrosion found in refrigeration systems. Pitting is usually a slow process causing isolated, scattered pits over an area. Contrary to blister rust, pitting and swelling rust both look severe, though oftentimes the piping can remain in service. Where piping has suffered wall loss in the range of 30-50%, the pipe needs to be cleaned of all corrosion and coated to protect from future effects of moisture.
