# The Integration of Inspection + Testing

## The Components of an Effective Ammonia Refrigeration System Evaluation

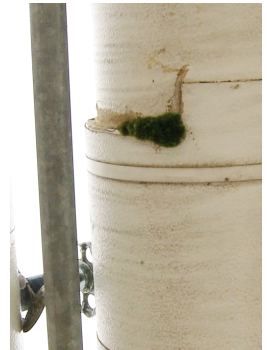
#### Example Scenario #1 Test to validate weakness

- 2 Biological growth found on piping jacketing.  
Likely that water is trapped in the insulation.  
The state of the piping is unknown.  
(Cannot be determined by visual inspection)

- 4 ✓ Extent of moisture is determined.
- ✓ Presence of corrosion is confirmed.
- ✓ Pipe wall thickness is measured.

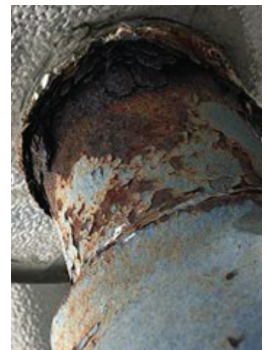
#### Example Scenario #2 Test to determine state

- 2 Corrosion on bare piping is found.  
Likely the pipe wall is thinning.  
The thickness of the piping is unknown.  
(Cannot be determined by visual inspection)

- 4 ✓ Pipe wall thickness is measured.

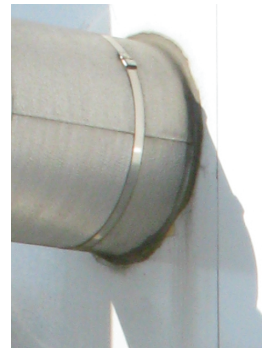
#### Example Scenario #3 Test to reveal concealed weakness

- 2 No visual indication of piping degradation at common failure point.  
Passes inspection.

- 4 ⚠ Insulation contains moisture.
- ⚠ Pipe is corroded.
- ⚠ 2" sched 80 pipe wall thickness measures as .10, 46% of nominal.
